Emerging Trends In Odor Control

Real World Case Studies

David Agee, PE, Stantec

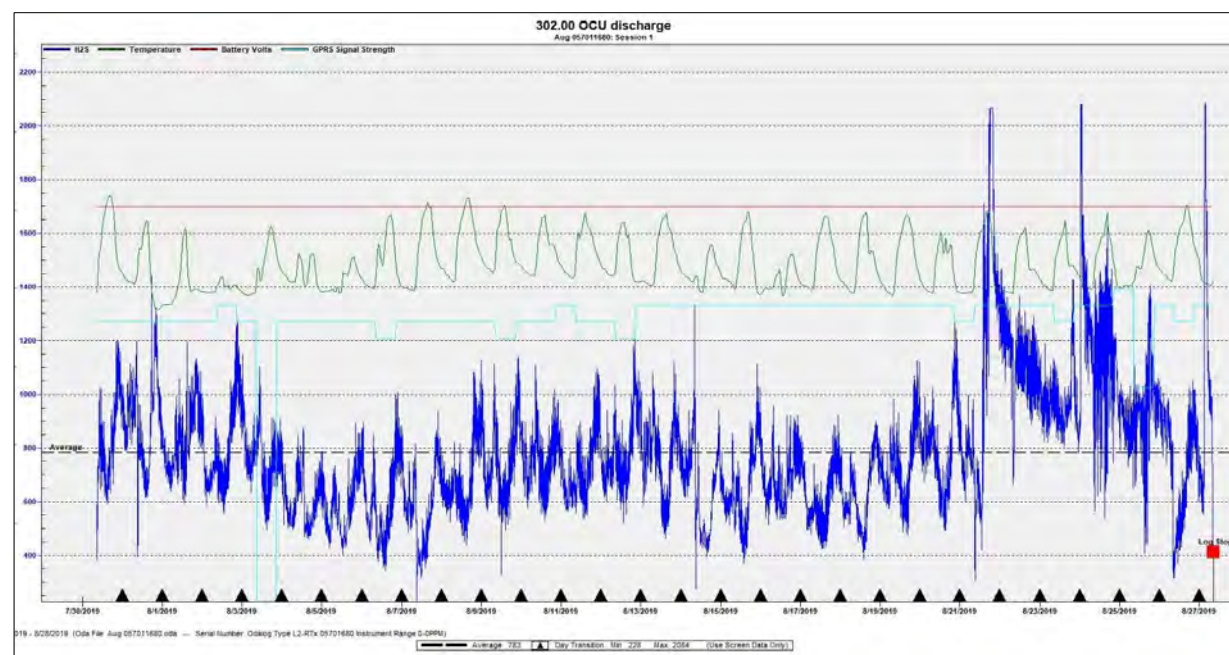
Master Pump Station 302

- Much higher H_2S in August 2019
- 800 ppm average H_2S
- Wet well cleaning interruption
- Carbon polishing scrubber added

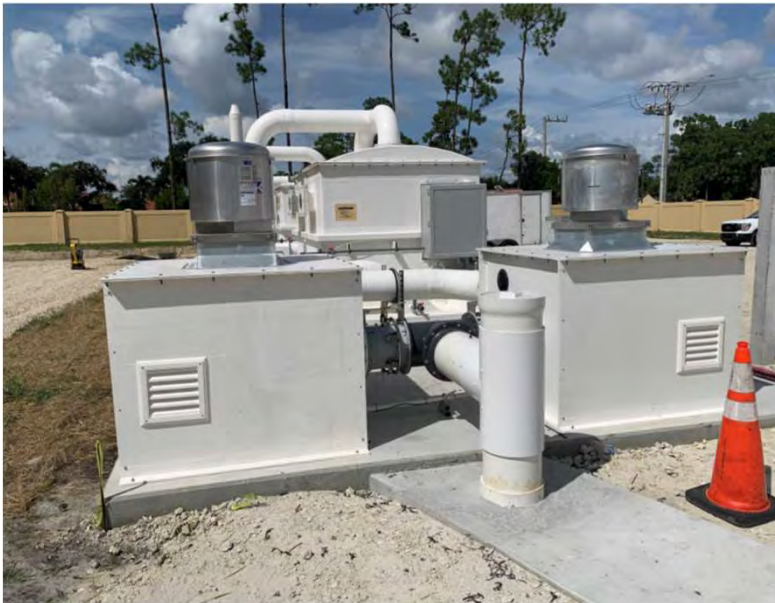
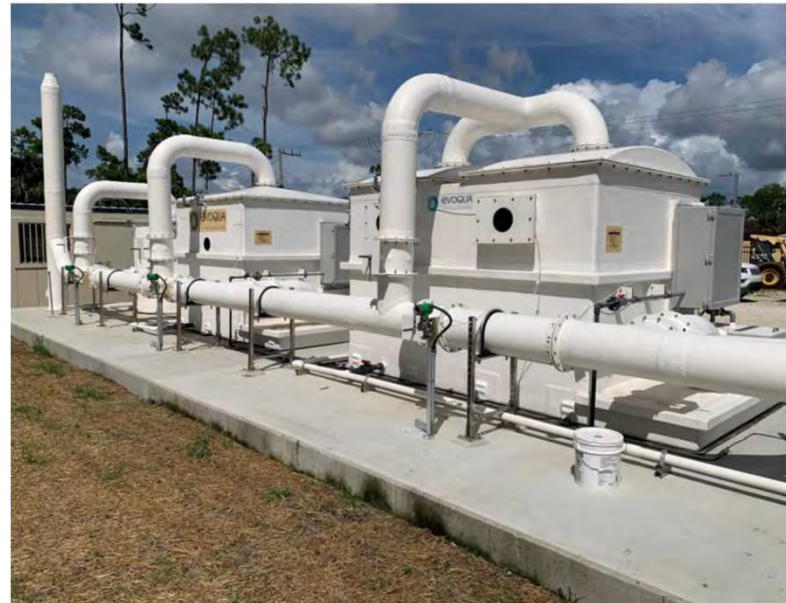
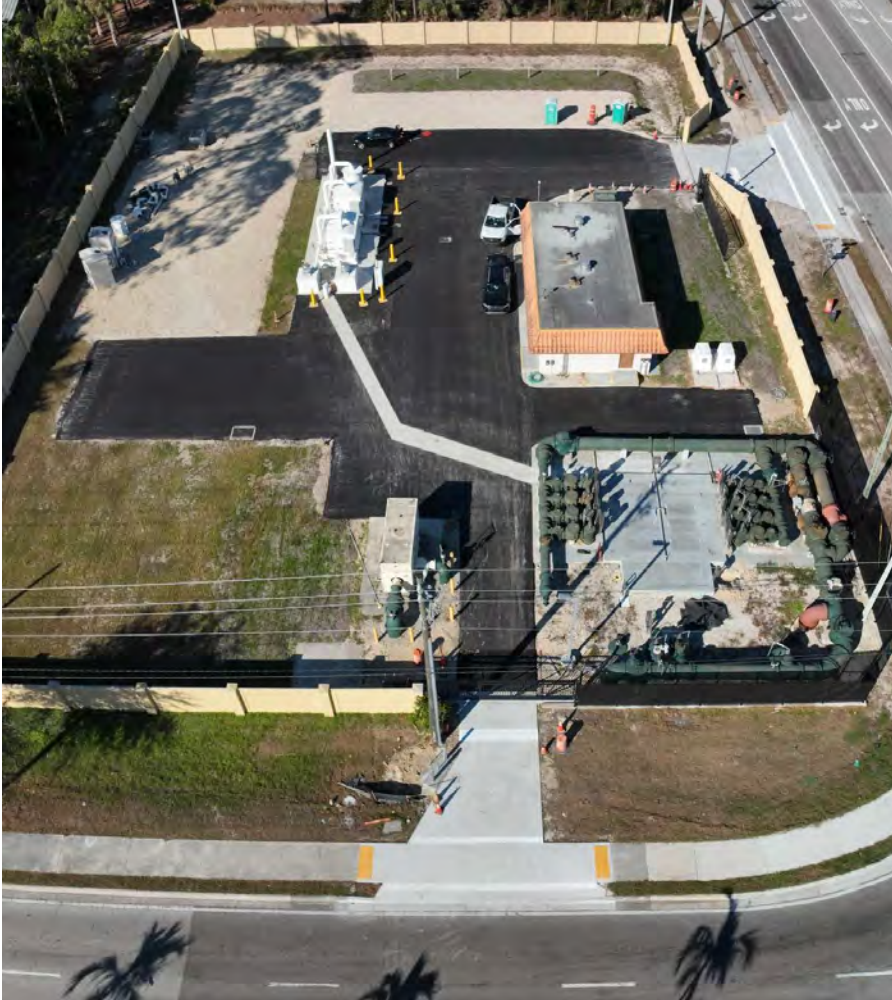
Master Pump Station 302

- 3 Treatment Units
- Ability to operate with 1, 2 or 3 units
- Dual Fans (1+1)
- Duct and dampers for flexibility

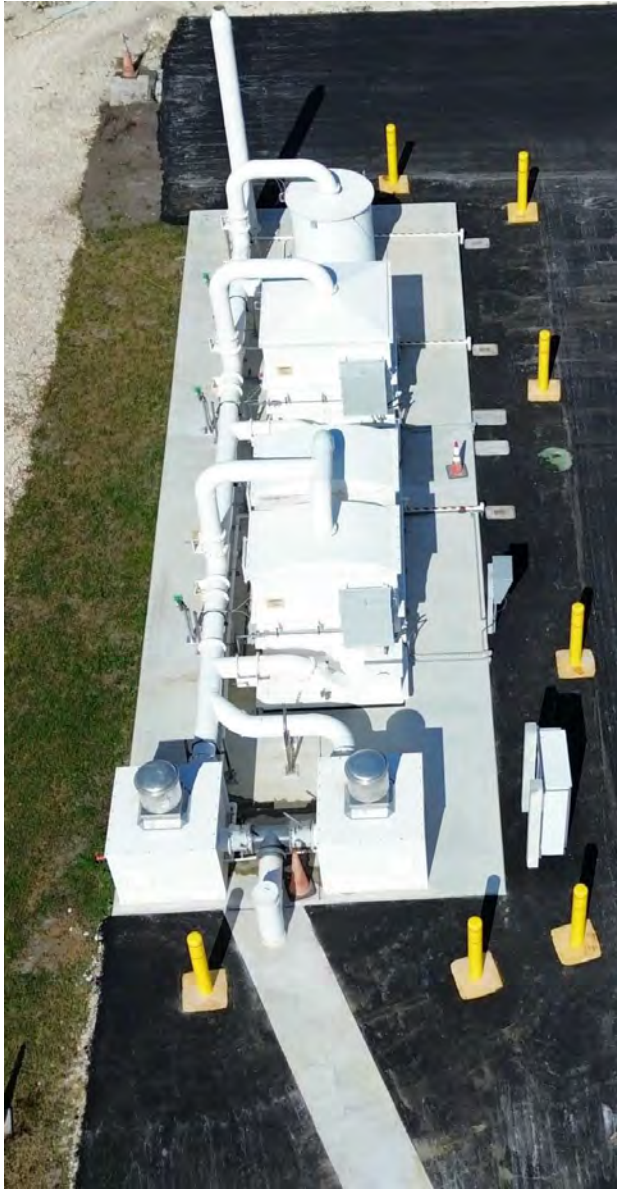
Drone View of Completed Project

- Note old Zaboc units along left fence for size comparison
- Site area more than doubled
 - Expanded drives and parking
 - Expanded stormwater detention/treatment
 - Space for larger, multi-stage system
- Improved access to all areas including new odor control system

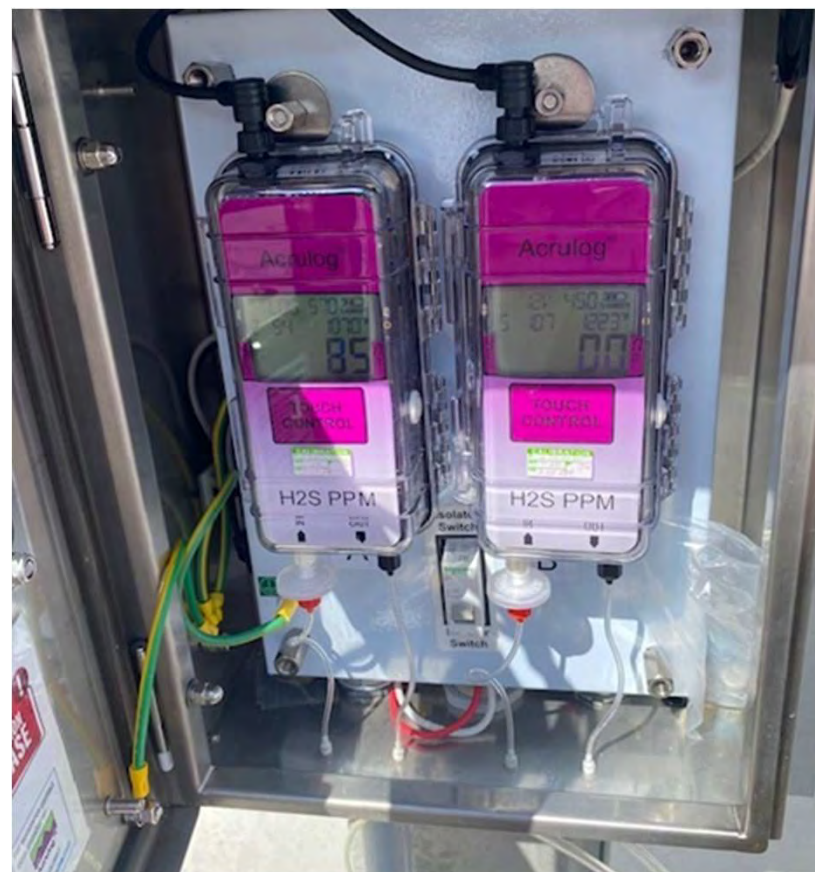
- New odor control system still in commissioning and testing
- Inlet H_2S 250 ppm avg. (Jan 2025)
- Data indicates >99.5% H_2S removal
- Moisture due to drain x-connect
- Drain issue corrected and commissioning and ongoing
- Wet well aeration now continuous to minimize H_2S spikes
- Performance testing pending

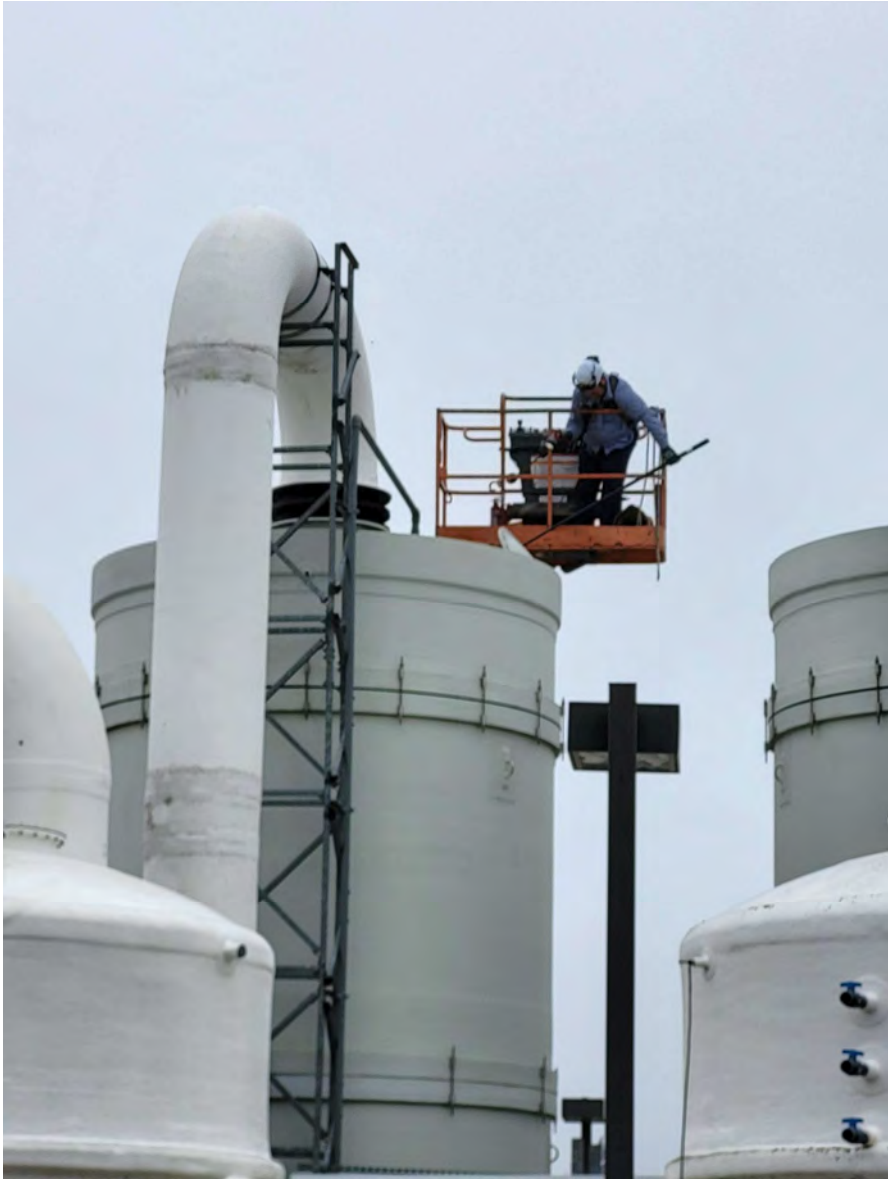
Large Pump Station on Interceptor Sewer

- 16,000 cfm Odor Control System
- 2-Stage Treatment
 - Bioway BTFs
 - Dual-bed carbon scrubbers
- Two Parallel Trains
- Bioxide Feed in Wet Well
- Gravity inflow
- Operating since 2009

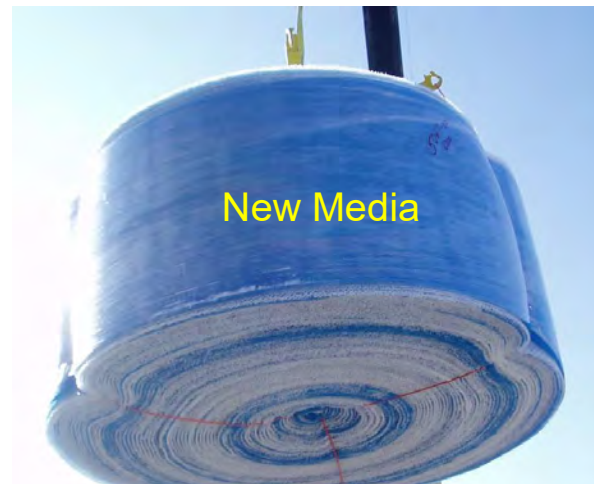
New Natomas Pump Station Media Condition

Media Closeup

- Physical Inspection did not indicate any major issues with media
- Irrigation spray pattern good, but coverage near vessel wall may be less than needed
- Spray nozzle replacement recommended
- Carbon media replacement recommended
- Restart North train BTF
- Evaluate process control including pH and flow rates of irrigation water

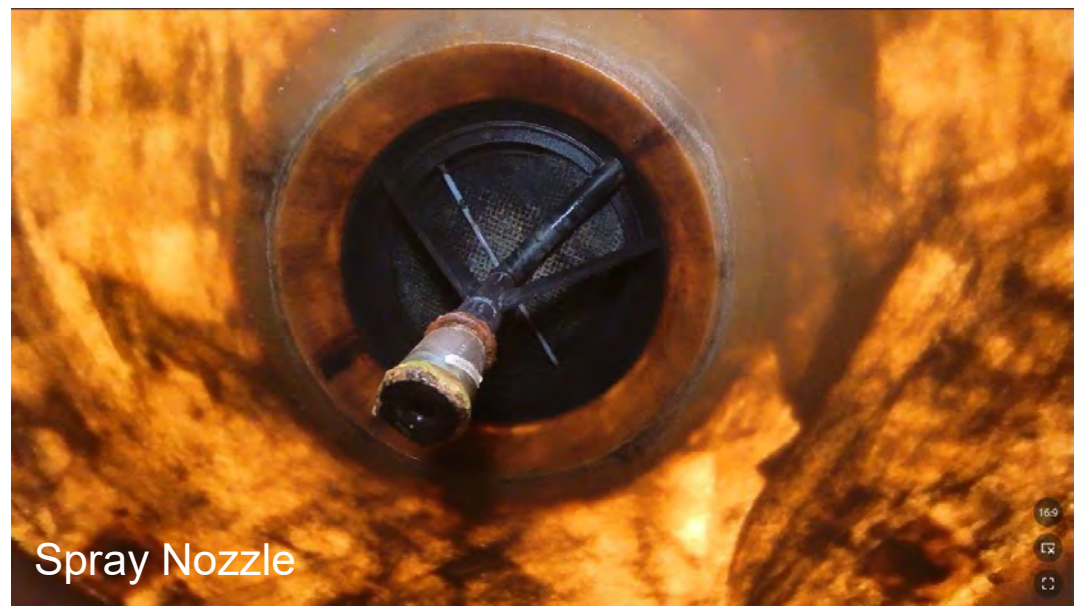
Spray Nozzle

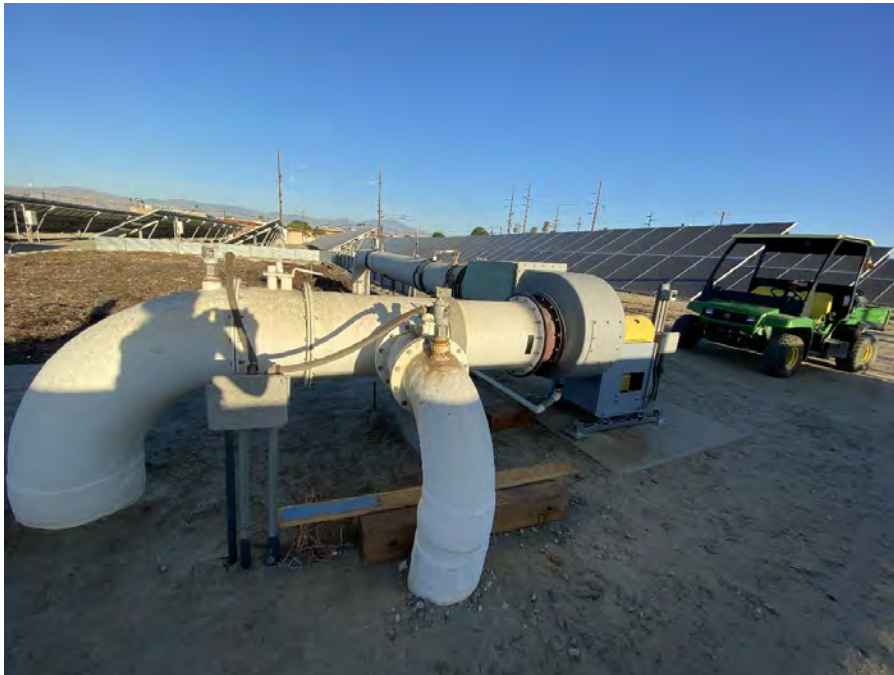
Biofilter Treating WWTP Headworks

- Original 3,000 cfm mulch biofilter operating since early 2000s
- Capacity increased to 4,000 cfm for headworks expansion project
- Biofilter was sufficient for 4,000 cfm
- New 4,000 cfm FRP fan installed

- New fan was underperforming
- Fan testing confirmed static pressure much higher than specified
- Biofilter inspection recommended to identify possible causes
- Video camera insertion revealed that air distribution piping under biofilter nearly half full of sand
- Project to clean air piping and replace media underway
